RE: A Communication from the Mayor regarding the emergency repairs made to the Crystal Lake Dike by the Greenwood Pool

I am writing to inform you of an emergency repair made at the Crystal Lake Dike that took place on Thursday, March 14, 2024.

-- Crystal Lake Dike --
Municipally-Owned Dike
PHASE I
INSPECTION/EVALUATION REPORT

Dam Name: Crystal Lake Dike
State Dam ID#: 3-14-103-21
NID#: MA01243
Owner: City of Gardner, MA
Owner Type: Municipal
City: Gardner
Consultant: CDR Maguire Inc.
Date of Inspection: April 8, 2014

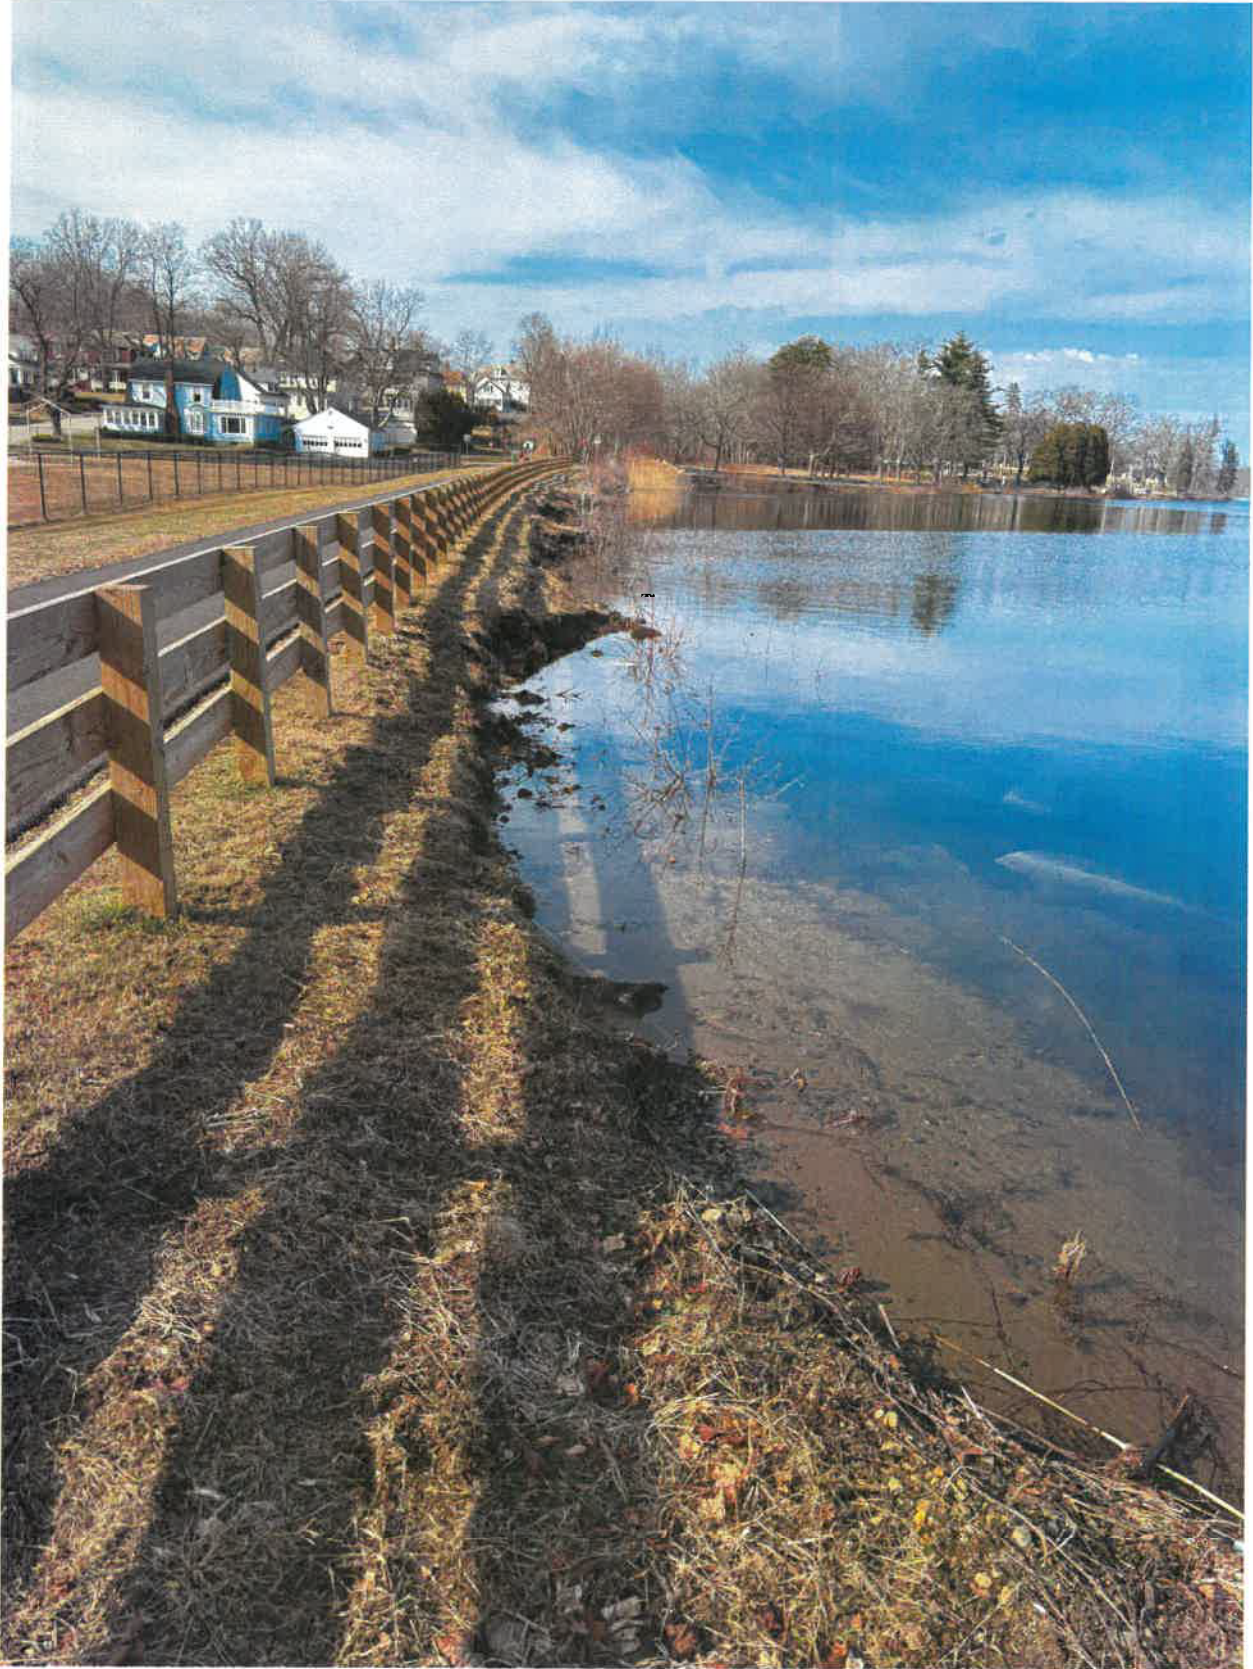
Before Repair

While visiting the new multi-use path/bike trail that was installed to change the color of the fence lights back to white, it was noted that not only was the water at Crystal Lake the highest it has been in years, but also that several feet of the dike that holds Crystal Lake from flowing into the Greenwood Pool/Monument Park area had eroded away due to the high winds we have been experiencing creating waves in the lake.

Additionally to stabilize the dike, the City install rip-rap stones along the shores of the lake to stabilize the dike.

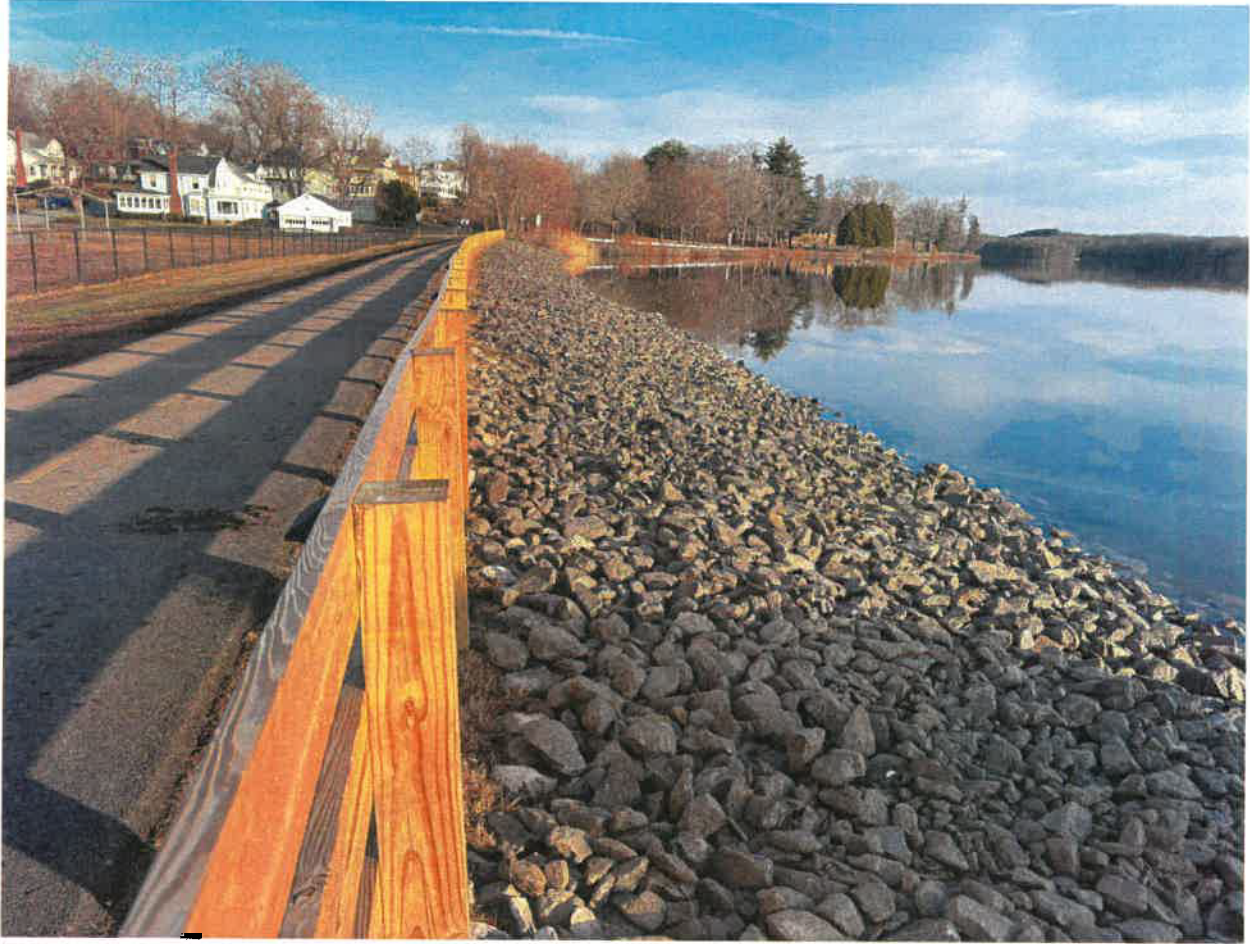
After Repair

The work has since been completed, the dike/dam stabilized, and the flooding concerns alleviated, however, I am writing to make sure you are aware of this entire situation in the event you receive any questions from our constituents.

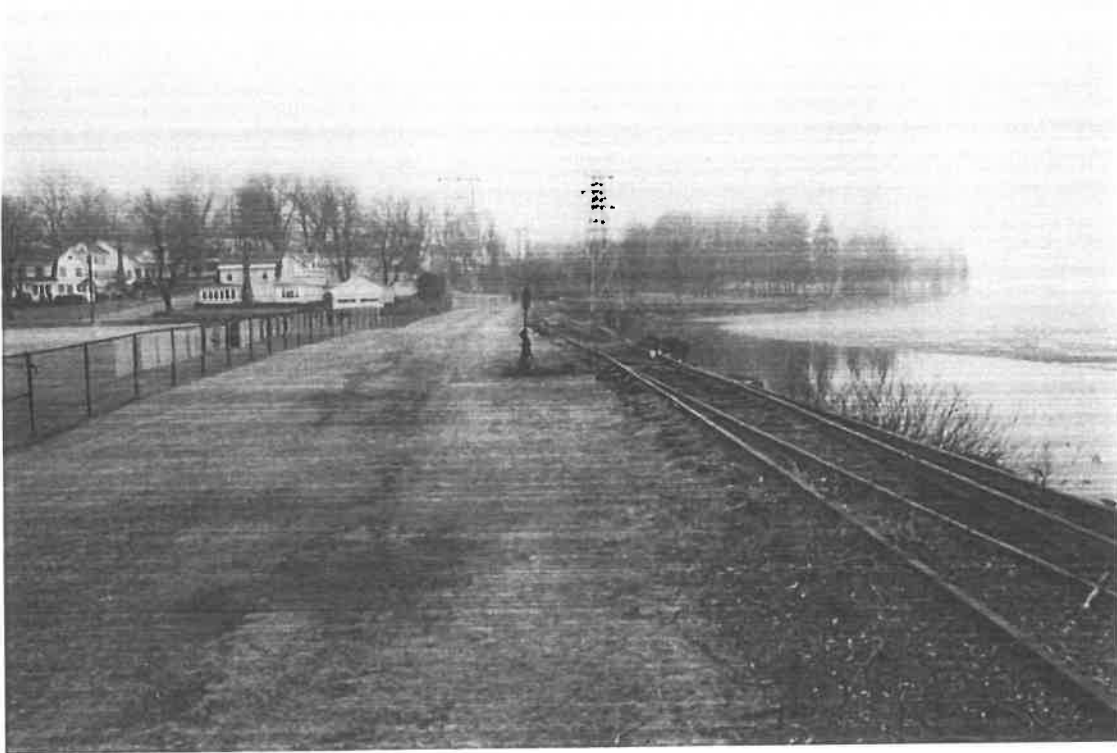
An abandoned railroad track runs the length of the crest of Crystal Lake Dike (see Photos). Also on the crest and next to the railroad tracks there is a grassed pathway which provides vehicular access along the dike. Tire ruts were observed along the pathway and vary in depth from 8-18 inches. There is light tree growth along the crest with tree diameter sizes ranging from 1 to 3 inches.

Photo B1: View of the dike crest looking towards the right abutment.

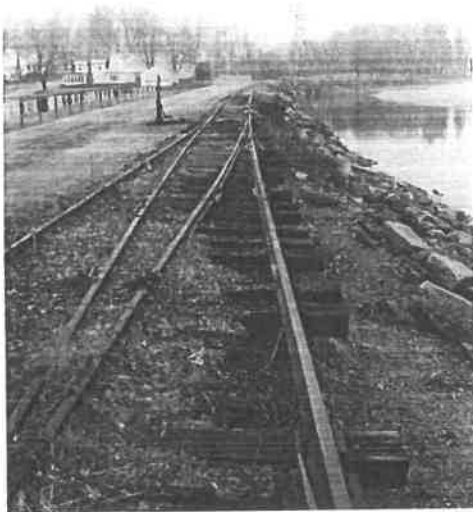
Photo B2: View of the dike crest looking towards the right abutment.

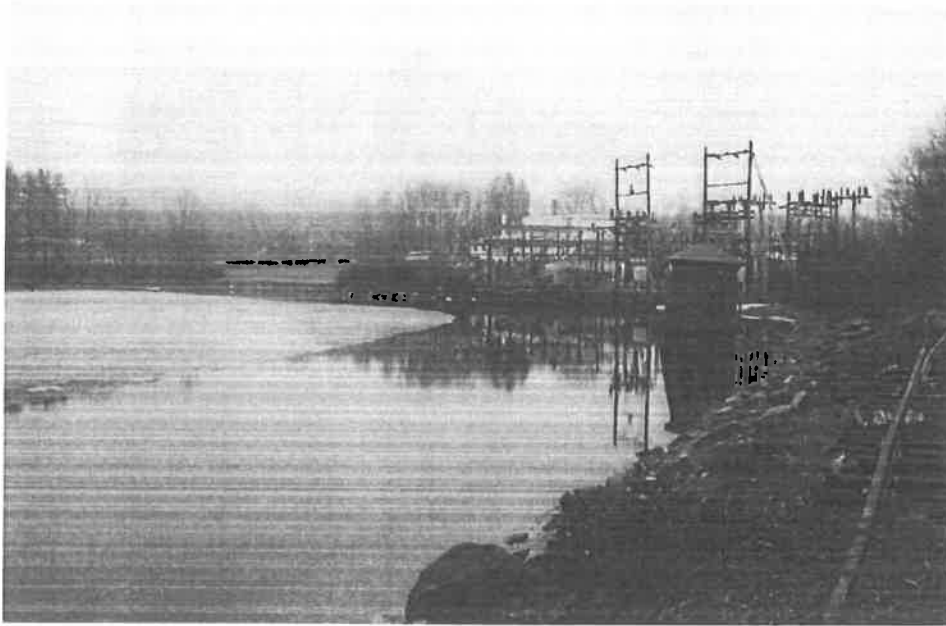
The upstream slope of the dike has missing riprap, and, in some locations, granite blocks along the crest have fallen into the lake. The loss of slope protection has led to significant erosion to the point that some railroad ties on the crest of the dike have become undermined. There is moderate vegetation along the upstream slope consisting of brush and trees ranging in size from 1 to 3 inches in diameter. The left and right embankment-to-abutment contact is good. There is moderate vegetation at the left and right abutment.

Photo B3: View of the dike upstream slope from right abutment.

1. The eroded areas on the upstream slope must be backfilled with granular fill and compacted to design grade. Riprap slope protection should be added to deter further erosion.
2. All brush on the slopes, crest, and left and right abutments of the dike should be removed. Excavations should be properly filled and compacted to insure the integrity of the embankment.
3. Institute a program of annual inspection by personnel from the Department of Public Works or its contract operator. The owner should also provide surveillance of the dike during intense rainfall.
4. A dike failure analysis should be computed to assess the downstream damage and impact.
5. Develop an Emergency Action Plan that will include an effective preplanned warning system; action to be taken at other reservoirs; locations of emergency

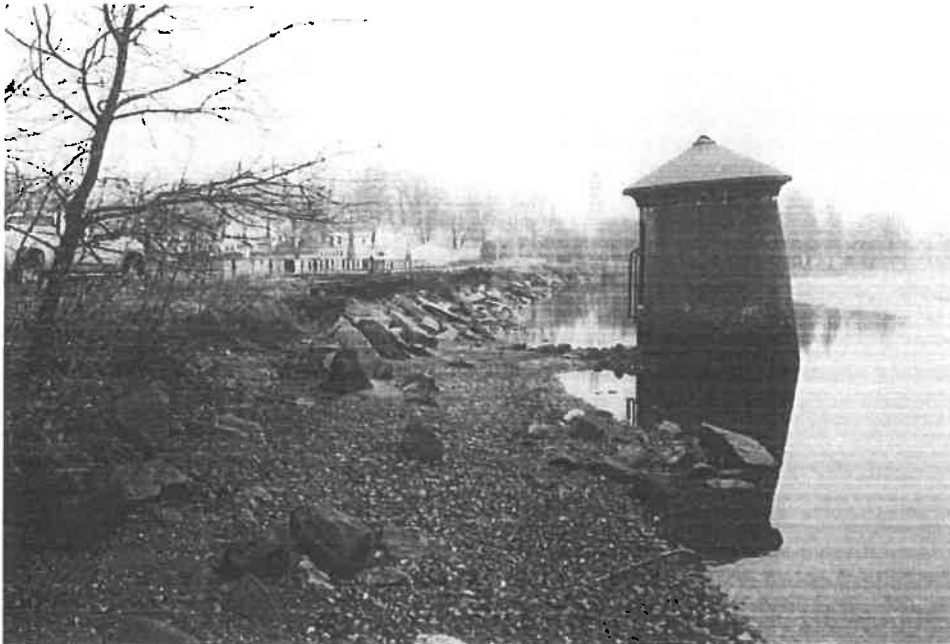
Photo B4: View of the dike upstream slope protection.

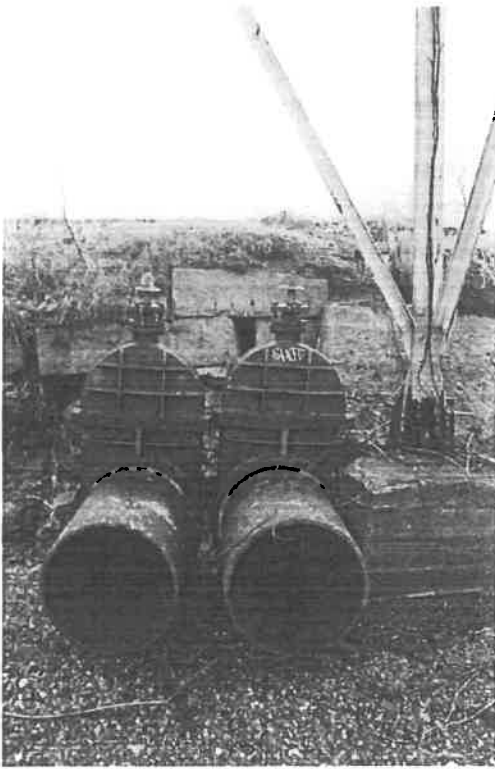
Two twin 20-inch pipes were observed entering the right portion of the upstream slope. Both pipes have visible gate valves. There also is a circular intake structure approximately 35 feet off shore. Access to it was not possible on the day of inspection. The status of any piping systems associated with it is unknown.

Photo B7: View of the twin 20-inch pipe entering the dike near the right abutment

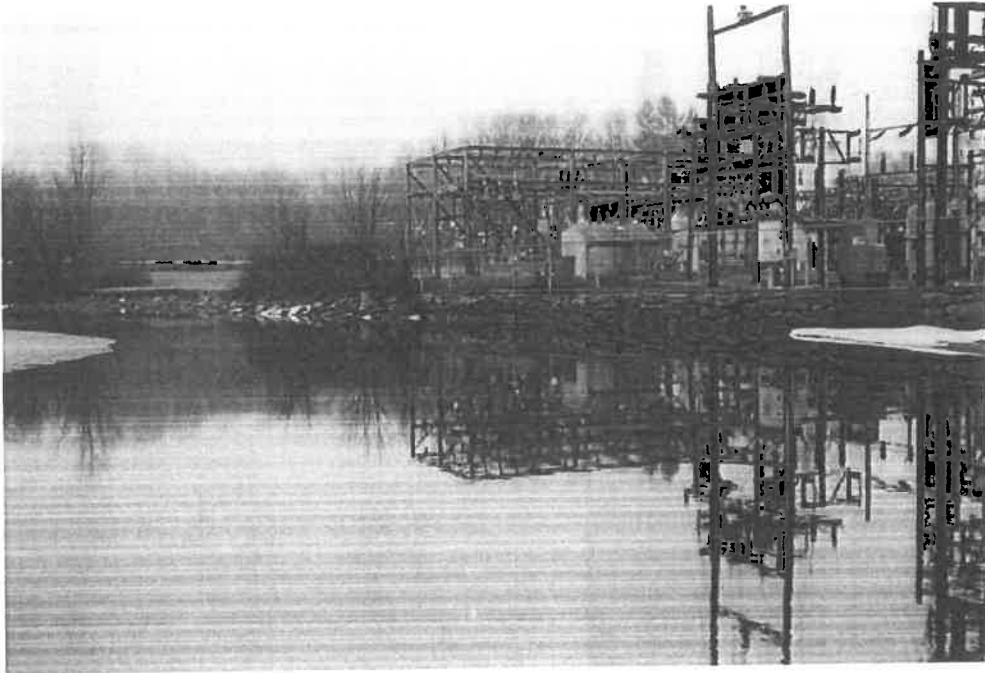
Photo B9: View of the upstream face of the dike

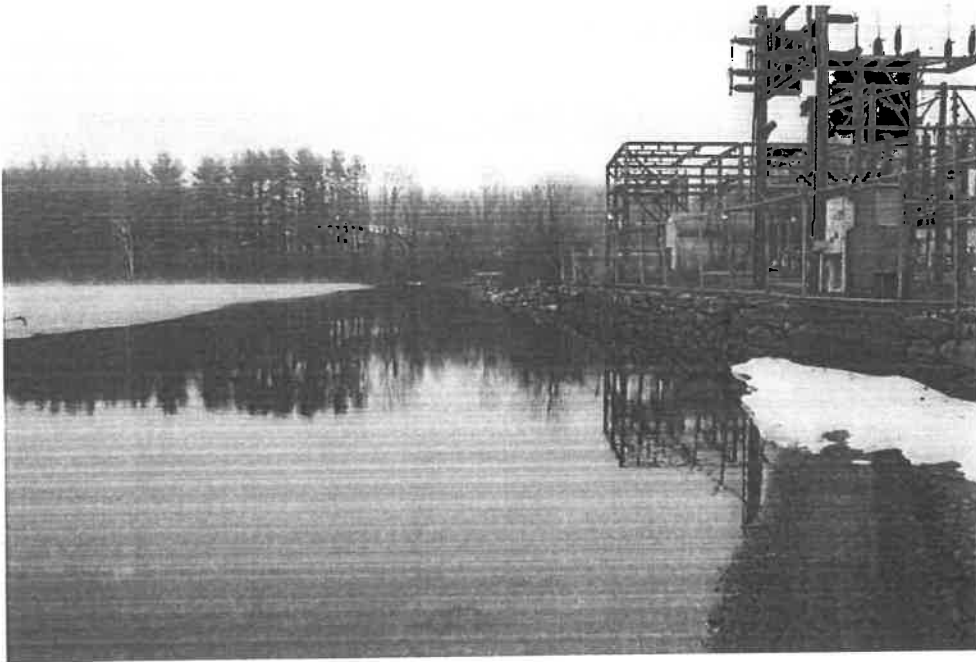
Photo B10: View of the upstream face of the dike

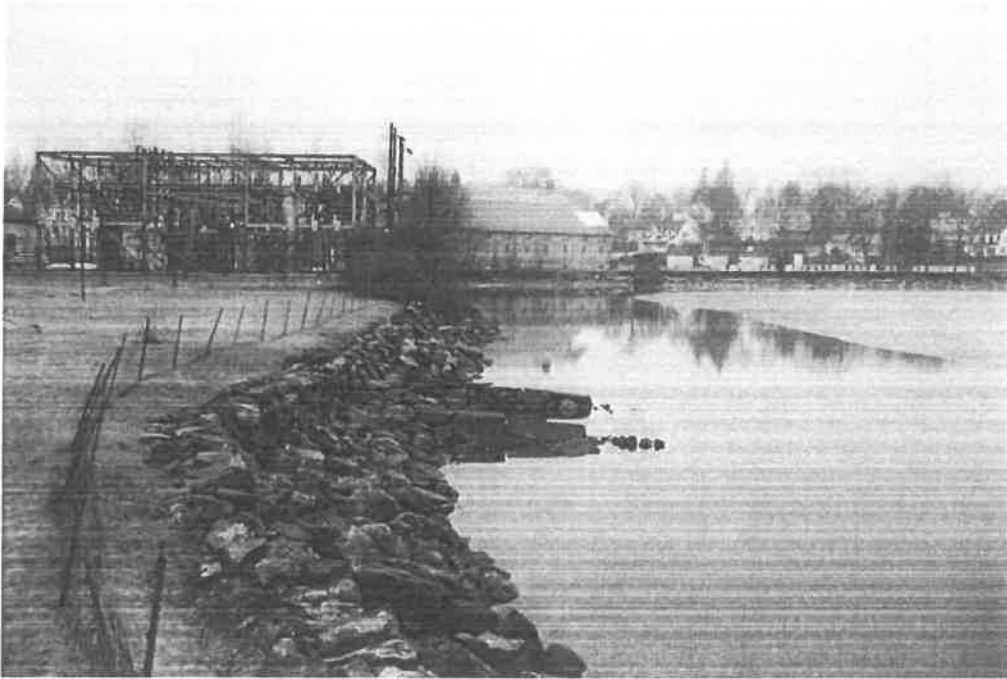
Photo B11: View of the upstream face from the left abutment
