Greenwood Memorial Pool

Gardner, Massachusetts

Facility Assessment and Study – FINAL DRAFT FOR REVIEW SUPPLEMENT

Bargmann Hendrie + Archetype, Inc.
Boston, MA

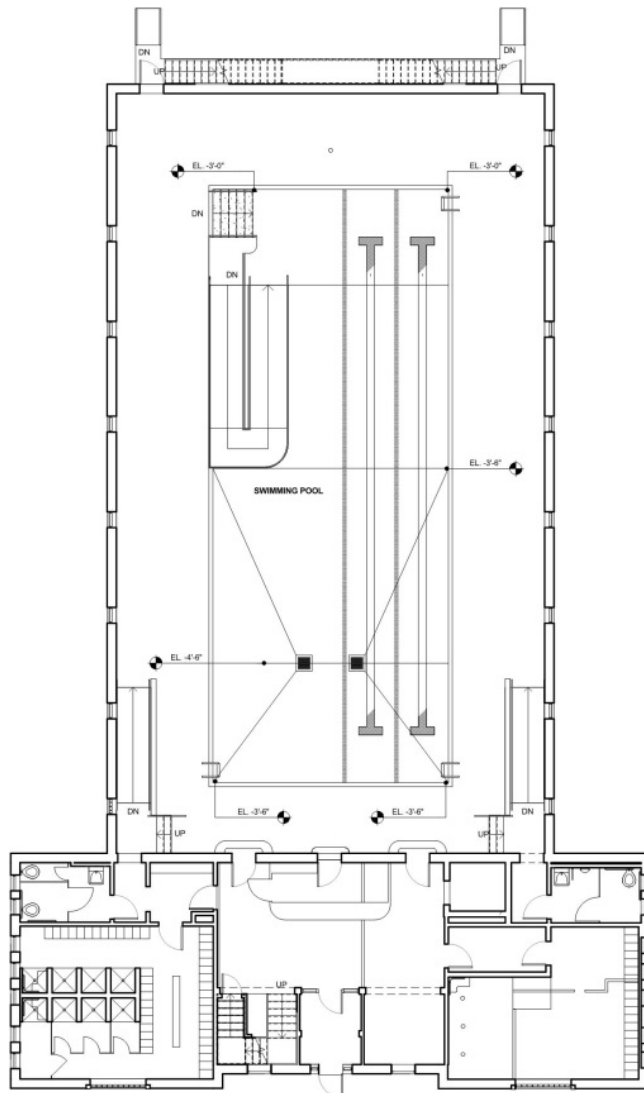
Option B (Ballard*King Option 1): This option will reconfigure the existing pool into a warm water pool that can be used for therapy, water exercise and lap swimming. New gunite will be placed within the existing tank to shallow-up the deep end of the pool and create a ramp and steps.

- Pool will be maximum of 4'-6" at the main drains
- Two lap lanes will be marked along one edge of the pool.
- Lane lines will be removed to provide a large 1,200 SF exercise/therapy area in the pool

Warm Water Lap and Therapy Pool

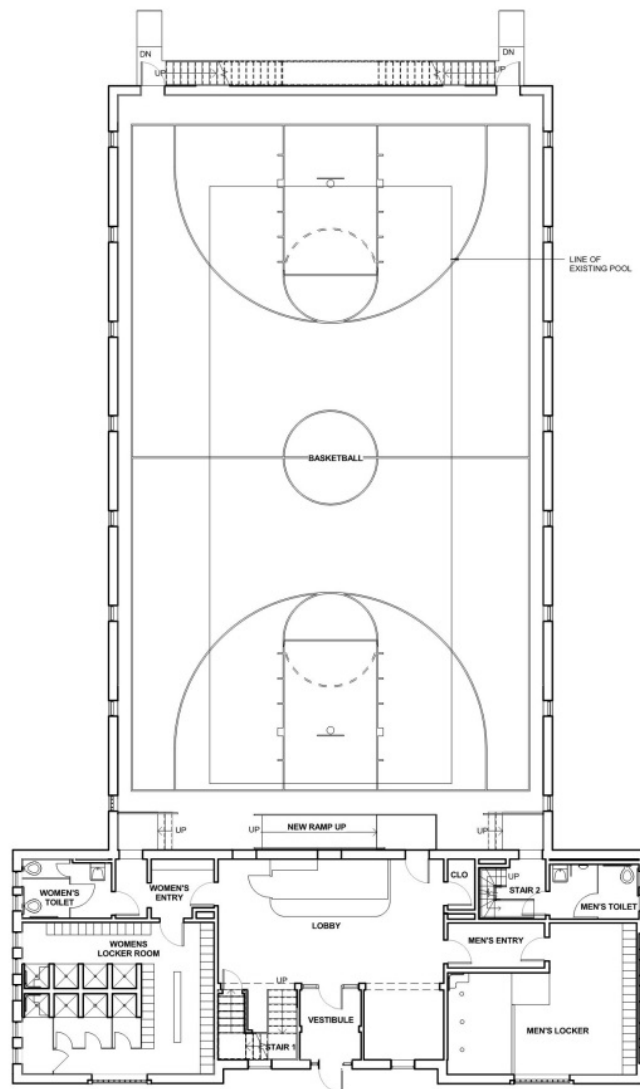
Option C (Ballard*King Option 2) In lieu of a pool program, the swimming pool would be filled in and the space would be provided with a multi-use floor surface. The former pool space could be used for basketball, volleyball, Futsol, pickle ball, lecture style seating, banquet seating, and small trade shows

Ventilation and heating unit would be provided without a pool dehumidification function. For summer use as well as banquet and lecture seating, air conditioning should be provided. Equipment to house the mechanical equipment should be located in the upper level of the support building; public access would be limited to the main level. We would maintain toilets and showers for the recreational functions; the toilets would not be sized for large lecture and banquet seating.

A ventilation and heating unit would be provided without a pool dehumidification function. For summer use as well as banquet and lecture seating, air conditioning should be provided.

We would maintain toilets and showers for the recreational functions; the toilets would not be sized for large lecture and banquet seating.

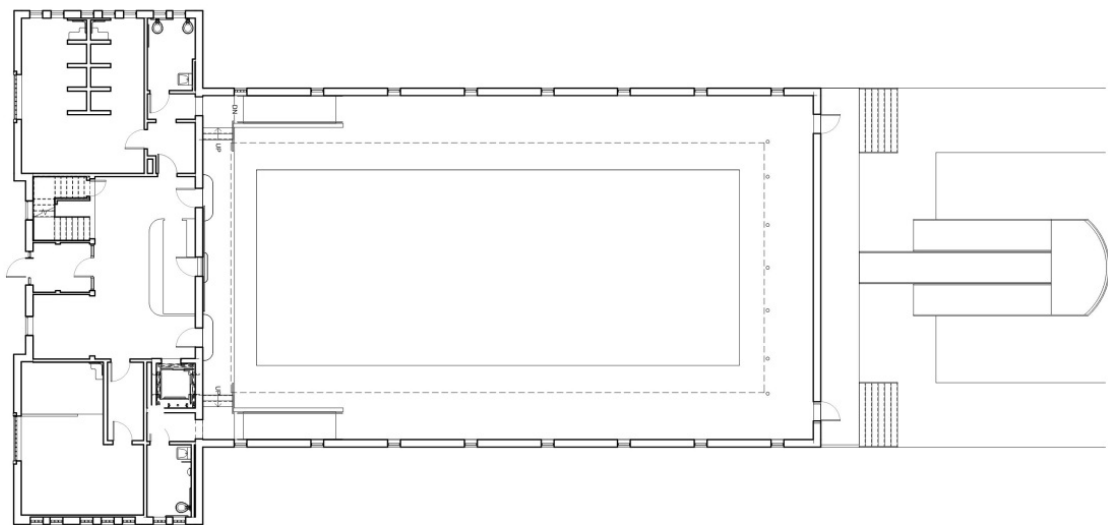
Option D.1: Maintain only the pool wing and create an outdoor pavilion to be used by the outdoor pool users or general public when the outdoor pool is closed.

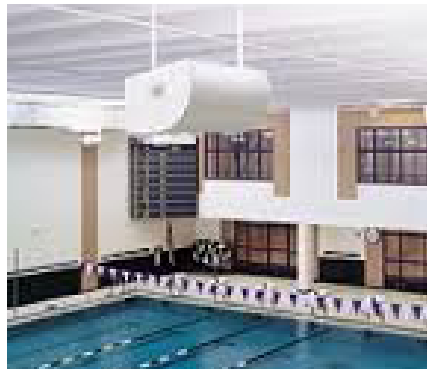
The pool deck area will be provided with decorative pendant fixtures, vapor tight and installed to access lamp replacement from the pool deck. Similar to SPI Echo Round light fixture shown below.

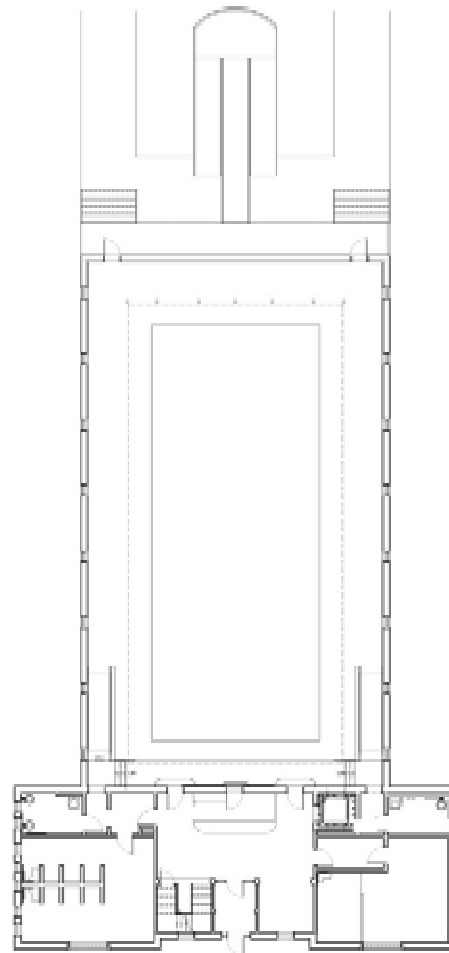
Option D: Multi-use space and toilets for outdoor pool

Option D: Maintain Support Building, including lockers and showers and use these facilities to support the outdoor pool. The large multi-use space would be used for summer camps and an indoor gather space for shade, meals, etc. by outdoor pool users.

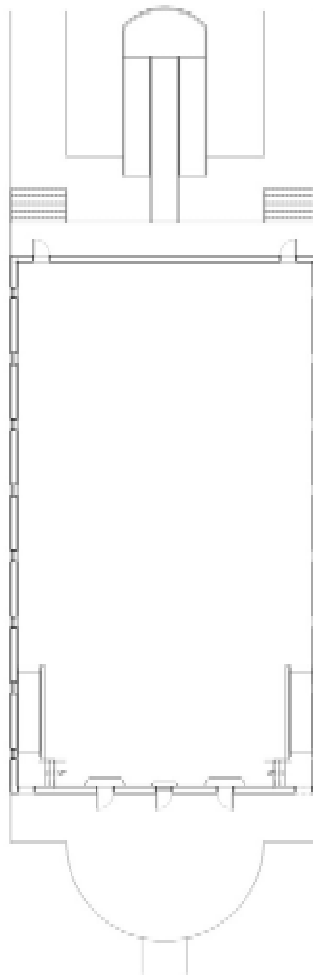
Option D.1- Open Pavilion for Outdoor Pool or Public Use
